**Flood Control Project Maintenance
Levee Inspections**
LMA District Cover Sheet
Spring 2019 Levee Inspection Results

Reclamation District No. 0341 Sherman Island

Spring 2019 Levee Inspection Results

Waterway			Bank	Unit Miles
Unit No. 01 Threemile Slough			Right	3.36
	Spring (March - May)	Summer (June - August)	(September - November) Fall	Winter (December - February)
Unit Maintenance Rating (Fall Only)				
Date of Inspection	3/28/2019 - 3/28/2019			
DWR Inspector	David Julian			
Accompanied By	Wade Wylie DWR

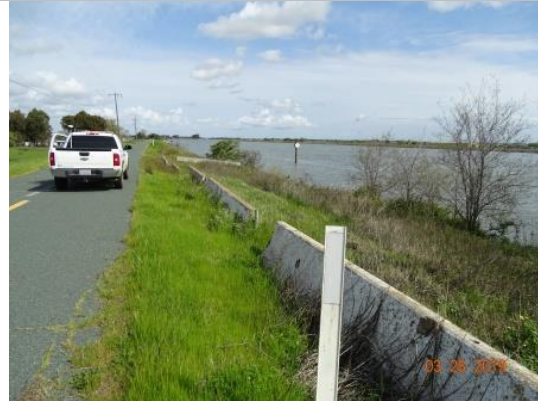
Photo 1 of 1 : SP_2019_RD0341_167_30_20190329_00054.jpg

LM Start	0.33	Rating **	A/W	Issue No.	30
LM End	0.33	Issue Type +	En	Location *	WS
Category	Earthen Levee			GPS Latitude/Longitude	
				Start	End
Item	Encroachments			38.090285 °	38.090285 °
				-121.686934 °	-121.686934 °
DWR ID	DWR_RD0341_01_s_2019_30				
Comment Code					
MA : Material					
Inspector Comment					
K-rail put in by LMA to stop vehicle traffic on the waterside slope around survey location.

View looking upstream at K-rail on the waterside shoulder. K-rail keeping vehicle traffic off of survey location. (Spring 2019)

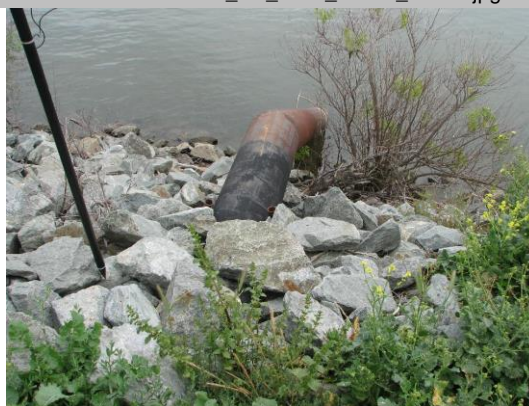
Photo 1 of 3 : UCIP_SP_2019_52255_37664.jpg

Comment Code						
Inspector Comment						
FS_ID:52255 DS_ID:24113 EP_NO: 11095 Repair Type: Non-Urgent Crossing Status: Found UCIP Comments: 07/06/2016 According to LMA Superintendent, Joel McElroy, this pipe is an irrigation siphon pipe and not a drainage pipe. Primer stem and primer is located on the LS near the berry shrubs. (DWR UCIP - O. Magana) 05/05/2009 Dense vegetation limits the inspector's visibility to identify signs of pipe failure (leaks) along the slope. Recommend removing vegetation along pipe alignment to conduct proper inspection of structure and appurtenances. (DWR UCIP - O. Magana) FIELD_STRUCT_DESC: 18-inch steel irrigation siphon pipe sleeved through 24-inch pipe through the levee, 4 feet below the crown. Primer stem and primer located on the landside (LS). Pipe exposed on the waterside (WS) slope. (18-inch pipe authorized under Automatic Board Order (ABO) issued as Permit No. 11095, 1975 - A. M. Cabral). [Additional Reference(s): DWR Levee Log, 1992. LMA encroachment station (STA) reference based on Map of Evacuation Route, Reclamation District 341 Sherman Island by Wagner Bonsignore Consulting Civil Engineers, A Corporation dated July 2012, STA 118+00] FS Date: 5/5/2009

View of pipe located on WS.

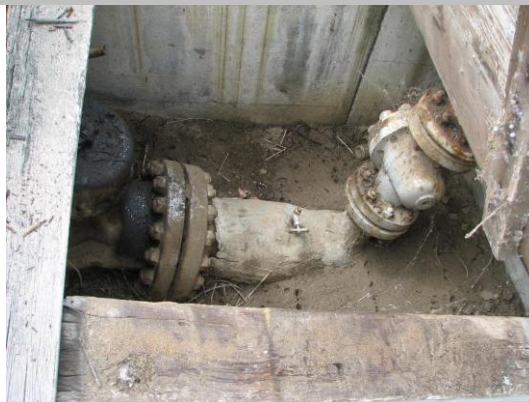
Photo 2 of 3 : UCIP_SP_2019_52257_37677.jpg

Comment Code					
Inspector Comment					
FS_ID:52257 DS_ID:24217 EP_NO: N/A Repair Type: Non-Urgent Crossing Status: Found UCIP Comments: 05/05/2009 Unknown detail of the size of crossing. Need to contact owner to determine if crossing is still active and to determine last inspection date. Will need copy of letter showing crossings passed inspection. NEED photo of emergency contact information from marker. (DWR UCIP - O. Magana) FIELD_STRUCT_DESC: Gas line of unknown material through the levee at an unknown depth below the levee crown. (no permit was found, field markers indicate owner is Pacific Gas and Electric Company [PG&E]) [Additional Reference(s): DWR Levee Log, 1992. USACE Sacramento O&M Manual Unit No. 101, February 1962, (HLM 1.44). LMA encroachment station (STA) reference based on Map of Evacuation Route, Reclamation District 341 Sherman Island by Wagner Bonsignore Consulting Civil Engineers, A Corporation dated July 2012, STA 98+00] FS Date: 5/5/2009

Inside view of vault located on the LS.

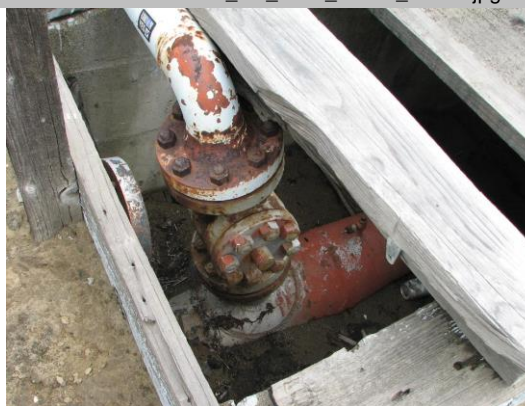
Photo 3 of 3 : UCIP_SP_2019_52257_37679.jpg

Comment Code					
Inspector Comment					
FS_ID:52257 DS_ID:24217 EP_NO: N/A Repair Type: Non-Urgent Crossing Status: Found UCIP Comments: 05/05/2009 Unknown detail of the size of crossing. Need to contact owner to determine if crossing is still active and to determine last inspection date. Will need copy of letter showing crossings passed inspection. NEED photo of emergency contact information from marker. (DWR UCIP - O. Magana) FIELD_STRUCT_DESC: Gas line of unknown material through the levee at an unknown depth below the levee crown. (no permit was found, field markers indicate owner is Pacific Gas and Electric Company [PG&E]) [Additional Reference(s): DWR Levee Log, 1992. USACE Sacramento O&M Manual Unit No. 101, February 1962, (HLM 1.44). LMA encroachment station (STA) reference based on Map of Evacuation Route, Reclamation District 341 Sherman Island by Wagner Bonsignore Consulting Civil Engineers, A Corporation dated July 2012, STA 98+00] FS Date: 5/5/2009

View of pipe inside concrete box located on LS.

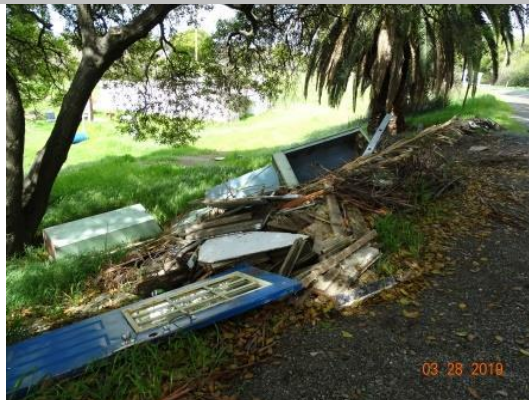
Photo 1 of 1 : SP_2019_RD0341_167_33_20190329_00056.jpg

LM Start	1.96	Rating **	M	Issue No.	33
LM End	1.96	Issue Type +	Ma	Location *	LS
Category	Earthen Levee			GPS Latitude/Longitude	
				Start	End
Item	Encroachments			38.113663 °	38.113663 °
				-121.684131 °	-121.684131 °
DWR ID	DWR_RD0341_01_s_2019_33				
Comment Code					
GA : Garbage					
Inspector Comment					
Remove garbage from landside slope.

View looking upstream at garbage pile on the landside slope (Spring 2019).

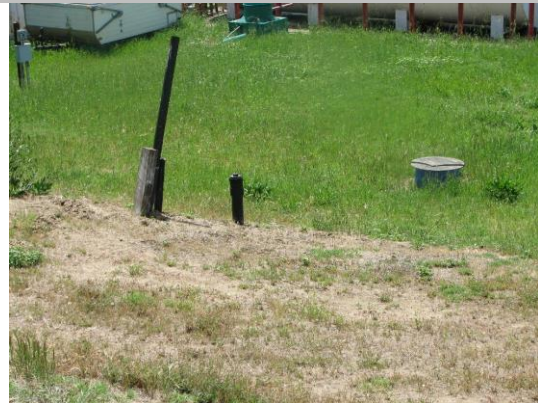
Photo 1 of 3 : UCIP_SP_2019_52259_37712.jpg

Comment Code						
Inspector Comment						
FS_ID:52259 DS_ID:24117 EP_NO: 5427 Repair Type: Non-Urgent Crossing Status: Indicator Found UCIP Comments: 07/06/2016 According to LMA Superintendent, Joel McElroy, the features on the LS include sump pump inside well and drain leach field. The septic line pumps from WS to LS and deposit water in hole. (DWR UCIP - O. Magana) 05/05/2009 Unable to find pipe or sump pump. Indicators found on landward side include potential septic tank and observation well. Need to contact owner of crossing to determine status of crossing. (DWR UCIP - O. Magana) FIELD_STRUCT_DESC: 1 of 2: 4-inch galvanized iron sewage pipe sleeved through 6-inch steel pipe through the levee, 3.7 feet below the crown. Sump pump located on the waterside (WS) slope. Septic tank and observation well are located on the landside (LS). (4-inch pipe authorized under Permit No. 5427, 1966 - Patrick's Resort) [Additional Reference(s): DWR Levee Log, 1992. LMA encroachment station (STA) reference based on Map of Evacuation Route, Reclamation District 341 Sherman Island by Wagner Bonsignore Consulting Civil Engineers, A Corporation dated July 2012, STA 69+00] FS Date: 5/5/2009

View of potential observation well on LS.

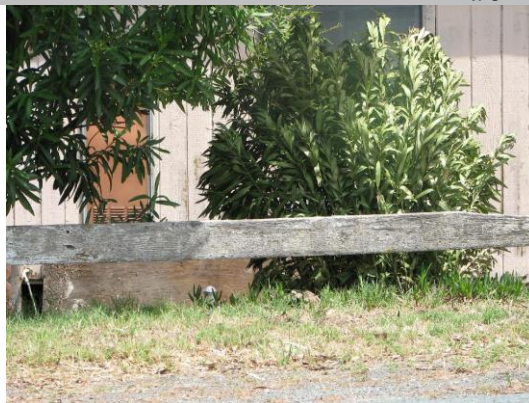
Photo 3 of 3 : UCIP_SP_2019_52259_37710.jpg

Comment Code						
Inspector Comment						
FS_ID:52259 DS_ID:24117 EP_NO: 5427 Repair Type: Non-Urgent Crossing Status: Indicator Found UCIP Comments: 07/06/2016 According to LMA Superintendent, Joel McElroy, the features on the LS include sump pump inside well and drain leach field. The septic line pumps from WS to LS and deposit water in hole. (DWR UCIP - O. Magana) 05/05/2009 Unable to find pipe or sump pump. Indicators found on landward side include potential septic tank and observation well. Need to contact owner of crossing to determine status of crossing. (DWR UCIP - O. Magana) FIELD_STRUCT_DESC: 1 of 2: 4-inch galvanized iron sewage pipe sleeved through 6-inch steel pipe through the levee, 3.7 feet below the crown. Sump pump located on the waterside (WS) slope. Septic tank and observation well are located on the landside (LS). (4-inch pipe authorized under Permit No. 5427, 1966 - Patrick's Resort) [Additional Reference(s): DWR Levee Log, 1992. LMA encroachment station (STA) reference based on Map of Evacuation Route, Reclamation District 341 Sherman Island by Wagner Bonsignore Consulting Civil Engineers, A Corporation dated July 2012, STA 69+00] FS Date: 5/5/2009

View of WS.

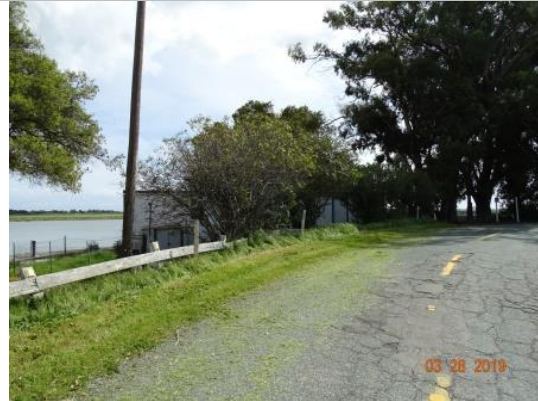
Photo 1 of 1 : SP_2019_RD0341_167_34_20190329_00057.jpg

LM Start	2.00	Rating **	M	Issue No.	34
LM End	2.00	Issue Type +	En	Location *	WS
Category	Earthen Levee			GPS Latitude/Longitude	
				Start	End
Item	Vegetation			38.114129 °	38.114129 °
				-121.684547 °	-121.684547 °
DWR ID	DWR_RD0341_01_s_2019_34				
Comment Code					
V6 : Landscaping					
Inspector Comment					
Remove landscaping on waterside.

View looking downstream at landscape on the waterside shoulder (Spring 2019).

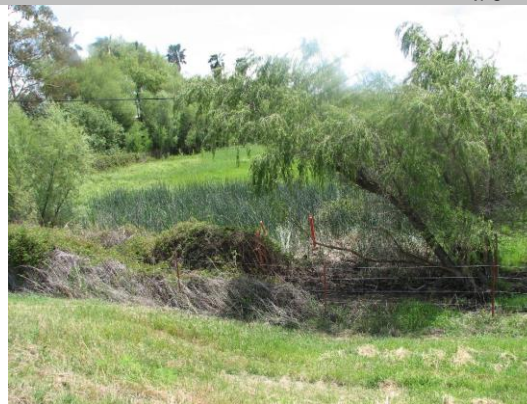
Photo 2 of 2 : UCIP_SP_2019_52263_71846.jpg

Markers visible on LS toe.

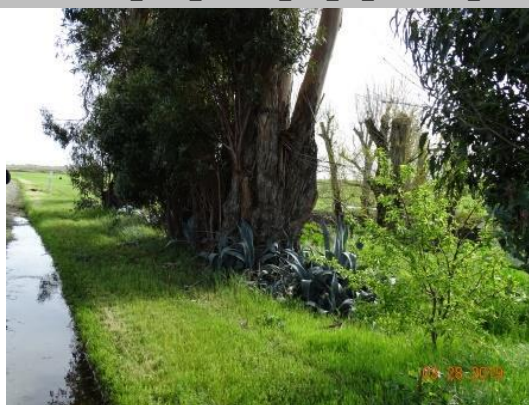
Photo 1 of 1 : SP_2019_RD0341_167_27_20190329_00051.jpg

LM Start	2.90	Rating **	M	Issue No.	27
LM End	2.90	Issue Type +	En	Location *	LS
Category	Earthen Levee			GPS Latitude/Longitude	
				Start	End
Item	Vegetation			38.104602 °	38.104602 °
				-121.694722 °	-121.694722 °
DWR ID	DWR_RD0341_01_s_2019_27				
Comment Code					
V6 : Landscaping					
Inspector Comment					
Cactus is blocking access down the landside slope.

View looking downstream at cactus on the landside slope (Spring 2019).

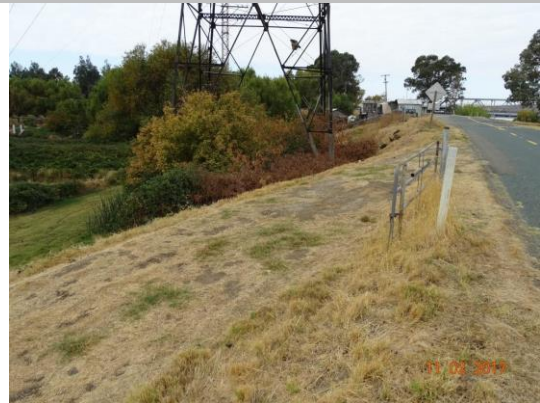
Photo 1 of 1 : SP_2019_RD0341_167_22_20190311_00003.jpg

LM Start	3.21	Rating **	M	Issue No.	22
LM End	3.21	Issue Type +	Ma	Location *	LS
Category	Earthen Levee			GPS Latitude/Longitude	
				Start	End
Item	Vegetation			38.104677 °	38.104677 °
				-121.700030 °	-121.700030 °
DWR ID	DWR_RD0341_01_f_2017_22				
Comment Code					
V2 : Remove the wild growth other than native grasses from the levee slopes.					
Inspector Comment					
Remove or thin wild vegetation at base of electrical transmission tower to allow visibility and access to slope and toe.

View of wild vegetation at base of electrical transmission tower.

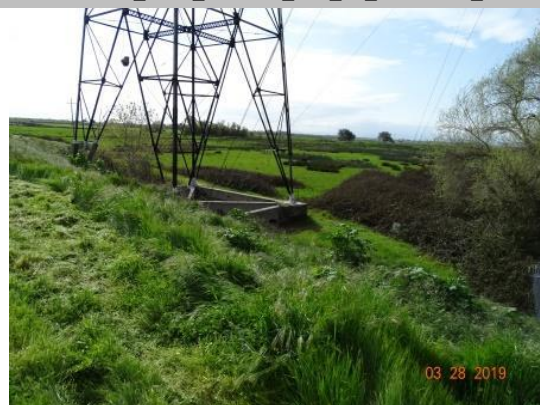
Photo 1 of 1 : SP_2019_RD0341_167_25_20190329_00050.jpg

LM Start	3.22	Rating **	U	Issue No.	25
LM End	3.22	Issue Type +	Ma	Location *	LS
Category	Earthen Levee			GPS Latitude/Longitude	
				Start	End
Item	Vegetation			38.104687 °	38.104687 °
				-121.700207 °	-121.700207 °
DWR ID	DWR_RD0341_01_s_2019_25				
Comment Code					
V1 : Control annual grass and weeds on the levee slopes and easements.					
Inspector Comment					
Maintain annual vegetation on the landside slope.

View looking downstream at annual vegetation on the landside slope (Spring 2019).

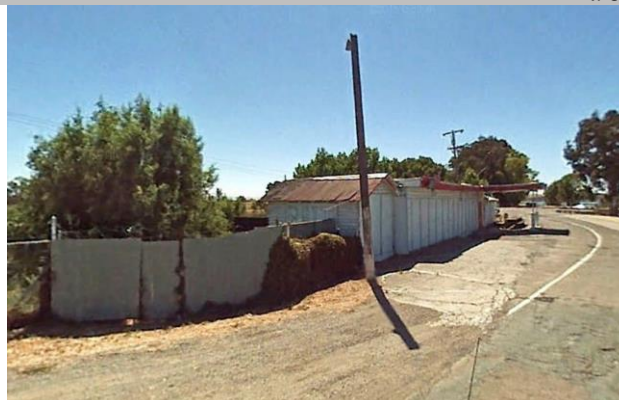
Photo 1 of 1 : SP_2019_RD0341_167_24_20190311_00005.jpg

LM Start	3.26	Rating **	U	Issue No.	24
LM End	3.26	Issue Type +	En	Location *	LS
Category	Earthen Levee			GPS Latitude/Longitude	
				Start	End
Item	Encroachments			38.104972 °	38.104972 °
				-121.700802 °	-121.700802 °
DWR ID	DWR_RD0341_01_f_2017_24				
Comment Code					
BU : Building					
Inspector Comment					
An unpermitted building is located on the landside of the levee.

View of unpermitted landside building.

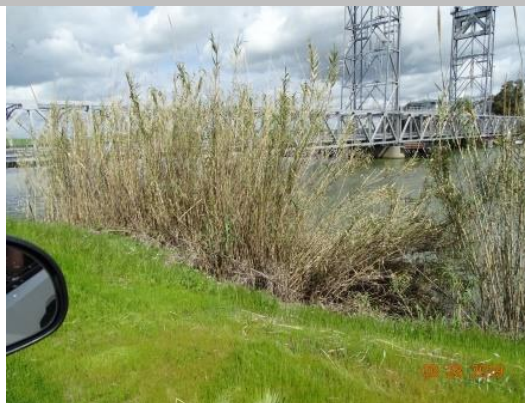
Photo 1 of 1 : SP_2019_RD0341_167_35_20190329_00058.jpg

LM Start	3.27	Rating **	M	Issue No.	35
LM End	3.27	Issue Type +	Ma	Location *	WS
Category	Earthen Levee			GPS Latitude/Longitude	
				Start	End
Item	Vegetation			38.105058 °	38.105058 °
				-121.701046 °	-121.701046 °
DWR ID	DWR_RD0341_01_s_2019_35				
Comment Code					
V2 : Remove the wild growth other than native grasses from the levee slopes.					
Inspector Comment					
Remove arundo from the waterside slope.

View looking upstream at arundo on the waterside slope (Spring 2019).

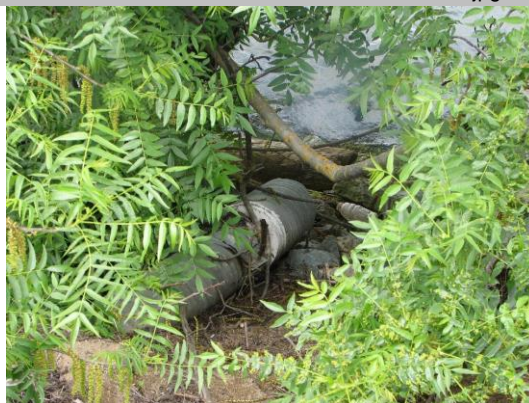
Photo 2 of 3 : UCIP_SP_2019_52267_37783.jpg

Pipe visible on the WS.

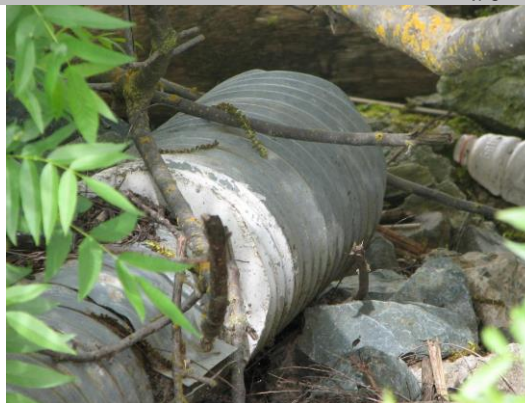
Photo 3 of 3 : UCIP_SP_2019_52267_37781.jpg

Comment Code						
Inspector Comment						
FS_ID:52267 DS_ID:24245 EP_NO: N/A Repair Type: Non-Urgent Crossing Status: Found UCIP Comments: 07/06/2016 According to LMA Superintendent, Joel McElroy, the pipe does not go through the levee. This pipe belongs to Caltrans. Need to contact Caltrans to obtain As-builts for this crossing. (DWR UCIP - O. Magana) 05/05/2009 New crossing found in field--need to find owner and determine permit authorizing work. (DWR UCIP - O. Magana) FIELD_STRUCT_DESC: *NOT THROUGH LEVEE* 10-inch corrugated metal pipe extruding from the waterside (WS) slope. [Additional Reference(s): LMA encroachment station (STA) reference based on Map of Evacuation Route, Reclamation District 341 Sherman Island by Wagner Bonsignore Consulting Civil Engineers, A Corporation dated July 2012, STA 1025+00] FS Date: 5/5/2009

View of corrugated metal pipe on WS.

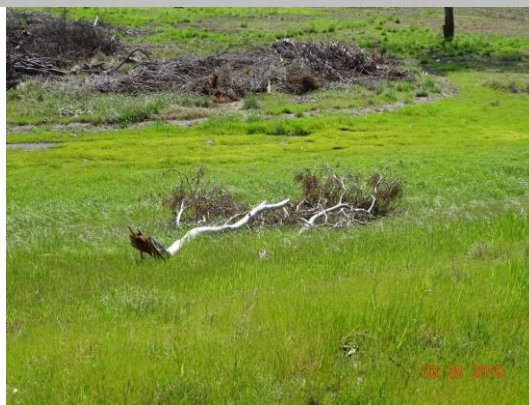
Photo 1 of 1 : SP_2019_RD0341_168_39_20190329_00088.jpg

LM Start	3.55	Rating **	M	Issue No.	39
LM End	3.55	Issue Type +	Ma	Location *	LS
Category	Earthen Levee			GPS Latitude/Longitude	
				Start	End
Item	Encroachments			38.103579 °	38.103579 °
				-121.705034 °	-121.705034 °
DWR ID	DWR_RD0341_02_s_2019_39				
Comment Code					
TR : Tree or limb					
Inspector Comment					
Remove tree limb from landside slope

View looking downslope at large tree branch on the landside slope (Spring 2019).

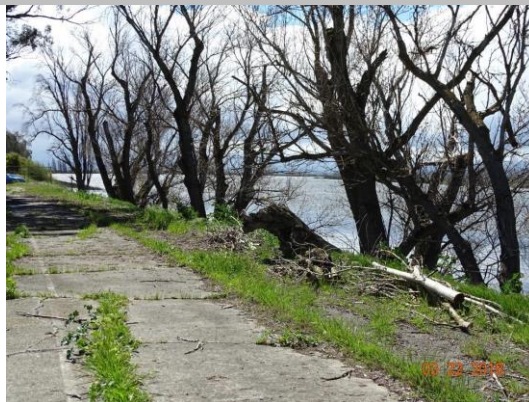
Photo 1 of 1 : SP_2019_RD0341_168_46_20190311_00013.jpg

LM Start	3.88	Rating **	M	Issue No.	46
LM End	3.88	Issue Type +	Ma	Location *	WS
Category	Earthen Levee			GPS Latitude/Longitude	
				Start	End
Item	Encroachments			38.099054 °	38.099054 °
				-121.706368 °	-121.706368 °
DWR ID	DWR_RD0341_02_s_2018_46				
Comment Code					
TR : Tree or limb					
Inspector Comment					
Remove tree and limbs from waterside shoulder.

Tree trunk and limbs should be removed from waterside shoulder.

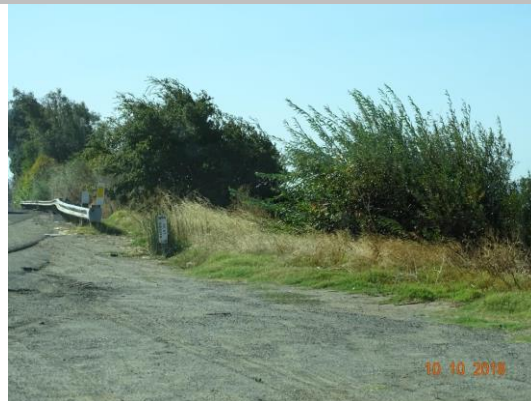
Photo 1 of 2 : SP_2019_RD0341_168_41_20190311_00005.jpg

LM Start	3.94	Rating **	U	Issue No.	41
LM End	6.14	Issue Type +	Ma	Location *	WS
Category	Earthen Levee			GPS Latitude/Longitude	
				Start	End
Item	Vegetation			38.098158 °	38.080223 °
				-121.706320 °	-121.730312 °
DWR ID	DWR_RD0341_02_s_2017_41				
Comment Code					
V2 : Remove the wild growth other than native grasses from the levee slopes.					
Inspector Comment					
Remove the unwanted vegetation from the waterside shoulder and slope.

Vegetation looking downstream at the beginning of where the levee is on Highway 160 (October 2018).

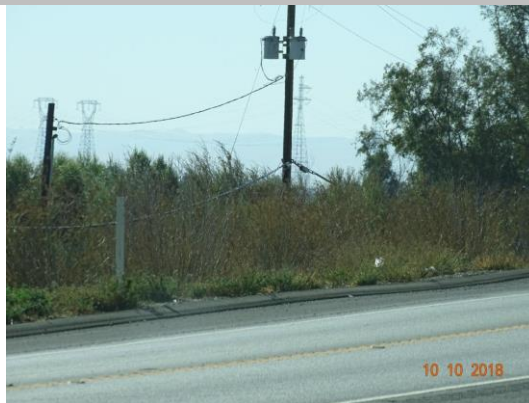
Photo 1 of 2 : SP_2019_RD0341_168_43_20190311_00010.jpg

LM Start	3.97	Rating **	M	Issue No.	43
LM End	6.03	Issue Type +	Ma	Location *	LS
Category	Earthen Levee			GPS Latitude/Longitude	
				Start	End
Item	Vegetation			38.097782 °	38.080143 °
				-121.706262 °	-121.728330 °
DWR ID	DWR_RD0341_02_f_2017_43				
Comment Code					
V2 : Remove the wild growth other than native grasses from the levee slopes.					
Inspector Comment					
Remove the unwanted vegetation from the landside shoulder, slope and toe.

View of vegetation on the land side slope where the levee is on Highway 160 (October 2018).

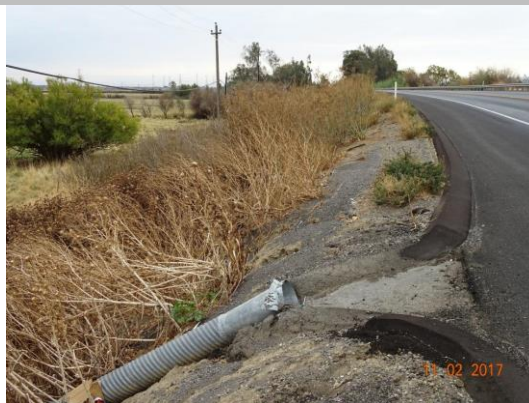
Photo 2 of 2 : SP_2019_RD0341_168_43_20190311_00011.jpg

LM Start	3.97	Rating **	M	Issue No.	43 (cont)
LM End	6.03	Issue Type +	Ma	Location *	LS

Remove the unwanted vegetation from the landside shoulder, slope and toe.

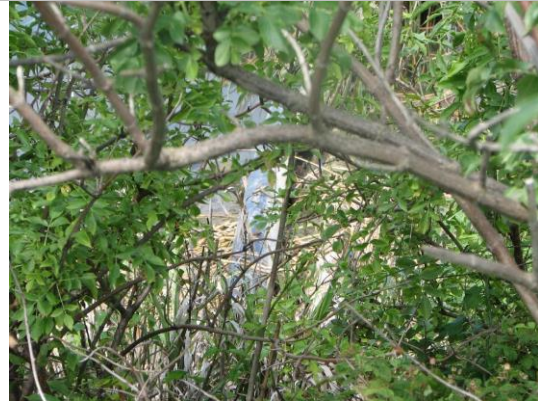
Photo 1 of 3 : UCIP_SP_2019_22203_37833.jpg

Comment Code						
Inspector Comment						
FS_ID:22203 DS_ID:24135 EP_NO: 11110 Repair Type: Non-Urgent Crossing Status: Found UCIP Comments: 07/06/2016 According to LMA Superintendent, Joel McElroy, DWR acquired land in 1995-2000 maybe earlier. Pipe is not used. Need to determine DWR Office is responsible for RD0341. Need to contact owner determine fate of crossing. (DWR UCIP - O. Magana) 05/06/2009 Need to determine status of crossing--need to contact owner. Dense vegetation limits the inspector's visibility to identify signs of pipe failure (leaks) along the slope. Recommend removing vegetation along pipe alignment to conduct proper inspection of structure and appurtenances. (DWR UCIP - O. Magana) FIELD_STRUCT_DESC: 10-inch steel irrigation pipe sleeved through 12-inch pipe through the levee, 3.8 feet below the crown. Pump on concrete well on landside (LS) slope. (10-inch pipe authorized under Automatic Board Order (ABO) issued as Permit No. 11110, 1975 - I. McKinnon, et al) [Additional Reference(s): DWR Levee Log, 1992. USACE Sacramento O&M Manual Unit No. 101, February 1962, (HLM 4.03). LMA encroachment station (STA) reference based on Map of Evacuation Route, Reclamation District 341 Sherman Island by Wagner Bonsignore Consulting Civil Engineers, A Corporation dated July 2012, STA 988+00] FS Date: 5/6/2009

Limited access to waterward side--pipe visible through brush.

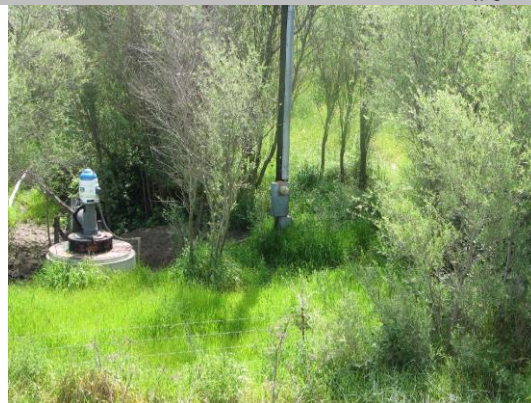
Photo 3 of 3 : UCIP_SP_2019_22203_37835.jpg

Comment Code						
Inspector Comment						
FS_ID:22203 DS_ID:24135 EP_NO: 11110 Repair Type: Non-Urgent Crossing Status: Found UCIP Comments: 07/06/2016 According to LMA Superintendent, Joel McElroy, DWR acquired land in 1995-2000 maybe earlier. Pipe is not used. Need to determine DWR Office is responsible for RD0341. Need to contact owner determine fate of crossing. (DWR UCIP - O. Magana) 05/06/2009 Need to determine status of crossing--need to contact owner. Dense vegetation limits the inspector's visibility to identify signs of pipe failure (leaks) along the slope. Recommend removing vegetation along pipe alignment to conduct proper inspection of structure and appurtenances. (DWR UCIP - O. Magana) FIELD_STRUCT_DESC: 10-inch steel irrigation pipe sleeved through 12-inch pipe through the levee, 3.8 feet below the crown. Pump on concrete well on landside (LS) slope. (10-inch pipe authorized under Automatic Board Order (ABO) issued as Permit No. 11110, 1975 - I. McKinnon, et al) [Additional Reference(s): DWR Levee Log, 1992. USACE Sacramento O&M Manual Unit No. 101, February 1962, (HLM 4.03). LMA encroachment station (STA) reference based on Map of Evacuation Route, Reclamation District 341 Sherman Island by Wagner Bonsignore Consulting Civil Engineers, A Corporation dated July 2012, STA 988+00] FS Date: 5/6/2009

View of well and pump located on landward side.

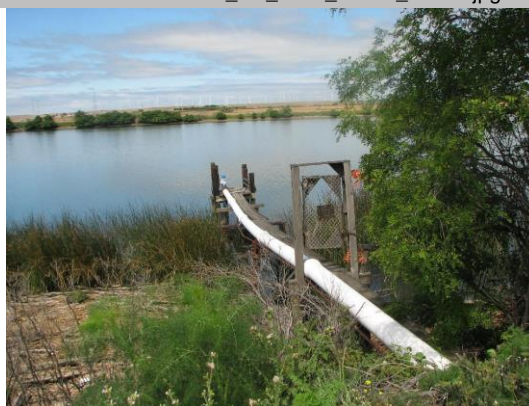
Photo 1 of 1 : UCIP_SP_2019_22223_37840.jpg

Comment Code					
Inspector Comment					
FS_ID:22223 DS_ID:24122 EP_NO: 11106 Repair Type: Non-Urgent Crossing Status: Found UCIP Comments: 07/06/2016 According to LMA Superintendent, Joel McElroy, DWR acquired land in 1995-2000 maybe earlier. Need to determine DWR Office is responsible for RD0341. Need to contact owner determine fate of crossing. (DWR UCIP - O. Magana) 05/06/2016 Need to contact owner to determine status of crossing. Dense vegetation limits the inspector's visibility to identify signs of pipe failure (leaks) along the slope. Recommend removing vegetation along pipe alignment to conduct proper inspection of structure and appurtenances. (DWR UCIP - O. Magana) FIELD_STRUCT_DESC: 12-inch pipe through the levee, 4 feet below the crown. Pump on pile structure in stream. (12-inch pipe authorized under Automatic Board Order (ABO) issued as Permit No. 11106, 1975 - A. and M. E. Cabral) [Additional Reference(s): DWR Levee Log, 1992. USACE Sacramento O&M Manual Unit No. 101, February 1962, (HLM 4.29). LMA encroachment station (STA) reference based on Map of Evacuation Route, Reclamation District 341 Sherman Island by Wagner Bonsignore Consulting Civil Engineers, A Corporation dated July 2012, STA 974+00] FS Date: 5/6/2009

View of waterward side--pipe and pump visible.

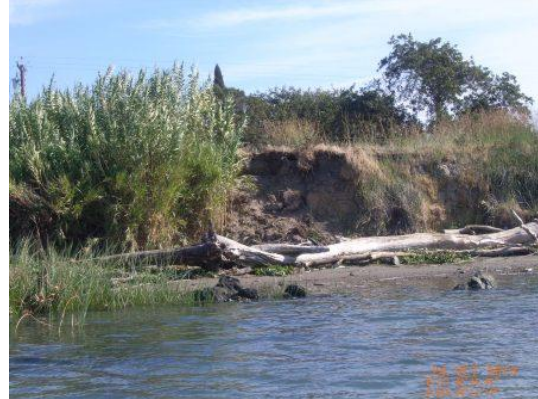
Photo 1 of 1 : SP_2019_RD0341_168_35_20190311_00003.jpg

LM Start	4.47	Rating **	U	Issue No.	35
LM End	4.70	Issue Type +	Ma	Location *	WS
Category	Supplemental			GPS Latitude/Longitude	
				Start	End
Item	2017 USACE Erosion Survey, DRAFT			38.090620 °	38.087425 °
				-121.706684 °	-121.707639 °
DWR ID	DWR_RD0341_02_f_2018_35				
Comment Code					
Inspector Comment					
2017 Site ID: SAC 8.0 L					
Status: Critical					
2017 Field Notes: Site extended downstream					
Site History: 1999 - New small slump in eroded bank. 2005 - Reach extended because of vertical bank along the roadway upstream. 2011 - More slumping since last year. 2012 - Site upgraded to critical. Very steep slope which may be effecting the highway on top of the levee. 2015 - New erosion towards the downstream end of site.

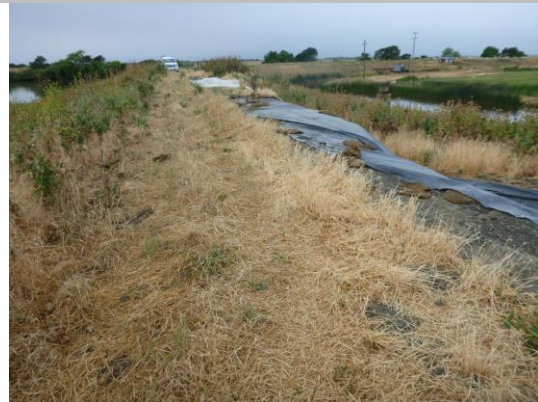
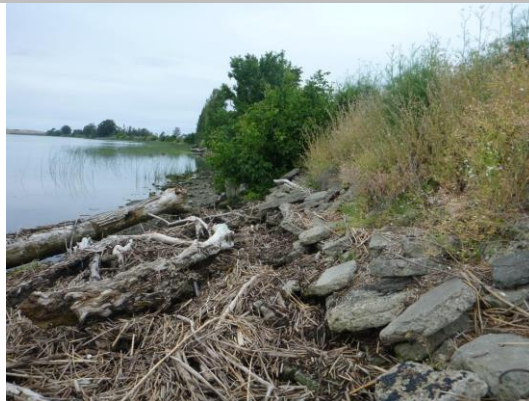
LM Start	4.75	Rating **	A/W	Issue No.	42
LM End	4.79	Issue Type +	Ma	Location *	
Category	Supplemental			GPS Latitude/Longitude	
				Start	End
Item	2017 Storm Damage			38.086641 °	38.086119 °
				-121.707545 °	-121.707912 °
DWR ID	DWR_RD0341_02_f_2017_42				
Comment Code					
Inspector Comment					
Levee Evaluation Comments					
Description:					
Site ID No:65					
Site Designation:DWR_RD0341_02_s_2012_8					
Repair Type: Erosion					
Rating:Area of Concern					
Field Date:6/8/2017					
Notes: hwy 160 forms levee crown road, erosion has encroached into paved crown, crown 38' wide. This site is currently under contract for repair under FSRP.

LM Start	4.75	Rating **	A/W	Issue No.	42 (cont)
LM End	4.79	Issue Type +	Ma	Location *	
Category	Supplemental			GPS Latitude/Longitude	
				Start	End
Item	2017 Storm Damage			38.086641 °	38.086119 °
				-121.707545 °	-121.707912 °
DWR ID	DWR_RD0341_02_f_2017_42				
Comment Code					
Inspector Comment					
Levee Evaluation Comments					
Description:					
Site ID No:65					
Site Designation:DWR_RD0341_02_s_2012_8					
Repair Type: Erosion					
Rating:Area of Concern					
Field Date:6/8/2017					
Notes: hwy 160 forms levee crown road, erosion has encroached into paved crown, crown 38' wide. This site is currently under contract for repair under FSRP.

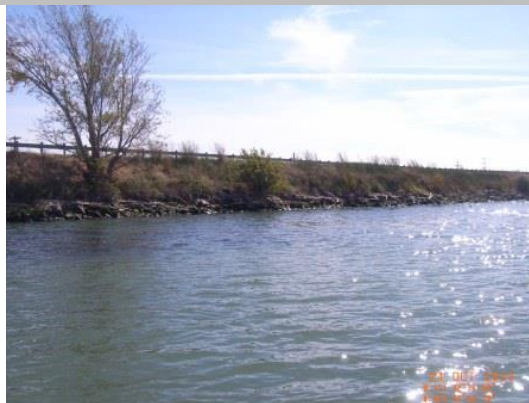
Photo 1 of 1 : SP_2019_RD0341_168_34_20190311_00002.jpg

LM Start	4.76	Rating **	A/W	Issue No.	34
LM End	5.01	Issue Type +	Ma	Location *	WS
Category	Supplemental			GPS Latitude/Longitude	
				Start	End
Item	2017 USACE Erosion Survey, DRAFT			38.086603 °	38.083954 °
				-121.707786 °	-121.710589 °
DWR ID	DWR_RD0341_02_f_2018_34				
Comment Code					
Inspector Comment					
2017 Site ID: SAC 7.9 L					
Status: Critical					
2017 Field Notes: Road base exposed in multiple locations. New tree popout observed.					
Site History: 2011 - Large slump section. 2012 - Site extended downstream, upgraded to critical, severe windwave. Slope is very steep and may be effecting the highway on top of the levee.

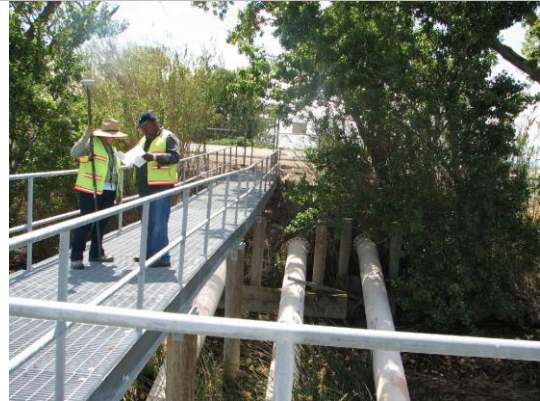
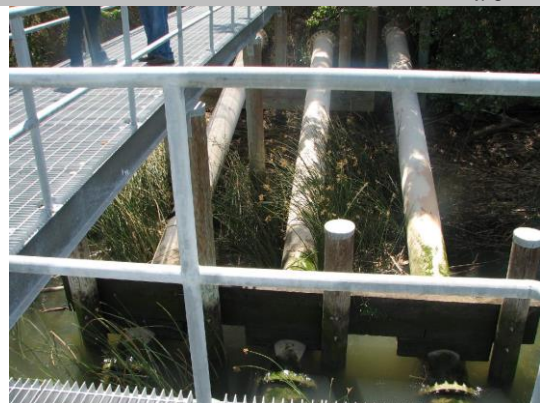
FS_ID:22253
DS_ID:24195
EP_NO: 15175
Repair Type: Non-Urgent
Crossing Status: Found
UCIP Comments: Dense vegetation limits the inspector's visibility to identify signs of pipe failure (leaks) along the slope. Recommend removing vegetation along pipe alignment to conduct proper inspection of structure and appurtenances.
FIELD_STRUCT_DESC: [Horseshoe Intake] 1 of 4: 24-inch steel irrigation pipe in 30-inch steel casings through the levee, 6.6 feet below the crown. Annular gap grouted between pipes. Siphon breakers located on the waterside (WS) shoulder, with concrete risers on both ends. Screened inlet manifold (36-inch) with backwash system on pile structure in stream. Surrounded by fence with entry gate. Irrigation pond located on the landside (LS) toe. (three 24-inch pipe authorized under Permit No. 15175, 1993 -Reclamation District 341 [RD0341]; replacement of 210 feet of existing 24-inch pipes, join two pipes at an inlet with a 36-inch screened manifold intake, add bypass valves on both lines, install an access platform, and pressurized backwash system to clean fish screens authorized under Permit No. 16737, 2000 - Department of Water Resources [DWR]) [Additional Reference(s): LMA encroachment station (STA) reference based on Map of Evacuation Route, Reclamation District 341 Sherman Island by Wagner Bonsignore Consulting Civil Engineers, A Corporation dated July 2012, STA 934+00] FS Date: 5/6/2009

Pipes, walkway, fence, and support piles located on waterward side.

View of waterward side - 3-20 inch pipes.

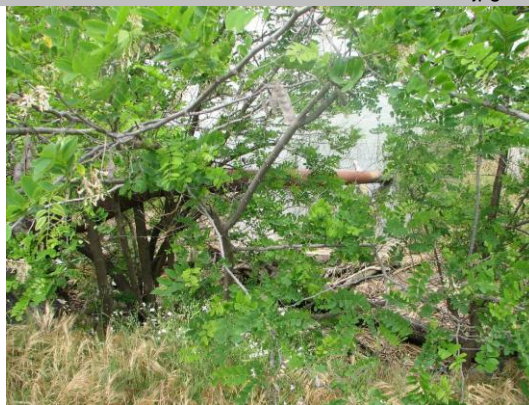
Overview of levee crown at crossing.

View of pipe through brush on waterward side.

Comment Code						
Inspector Comment						
FS_ID:22256 DS_ID:24127 EP_NO: 11116 Repair Type: Non-Urgent Crossing Status: Found UCIP Comments: Need to coordinate with owner to determine status of crossing. If crossing is no longer in use owner will need to contact the CVFPB to comply with Title 23. Dense vegetation limits the inspector's visibility to identify signs of pipe failure (leaks) along the slope. Recommend removing vegetation along pipe alignment to conduct proper inspection of structure and appurtenances. FIELD_STRUCT_DESC: 16-inch steel irrigation pipe sleeved through 18-inch pipe through the levee, 2.5 feet below the crown. Annular gap grouted. Air vent on waterside (WS). (16-inch sleeved through 18-inch pipe authorized under Automatic Board Order (ABO) issued as Permit No. 11116, 1975 - C. E. & J. E. Upham; widen and realign State HWY 160 and extend three irrigation pipes authorized under Permit No. 15372, 1993 - Department of Transportation [Caltrans]) [Additional Reference(s): DWR Levee Log, 1992. USACE Sacramento O&M Manual Unit No. 101, February 1962, (HLM 5.40). LMA encroachment station (STA) reference based on Map of Evacuation Route, Reclamation District 341 Sherman Island by Wagner Bonsignore Consulting Civil Engineers, A Corporation dated July 2012, STA 917+00] FS Date: 5/6/2009

Pipe on waterward side at daylight.

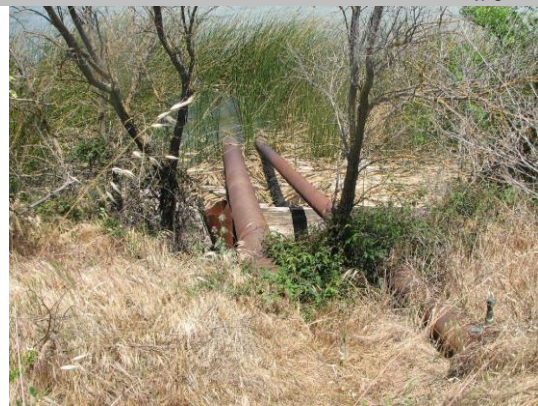
Photo 1 of 3 : UCIP_SP_2019_22258_37932.jpg

Comment Code						
Inspector Comment						
FS_ID:22258 DS_ID:24074 EP_NO: 11116 Repair Type: Non-Urgent Crossing Status: Found UCIP Comments: Dense vegetation limits the inspector's visibility to identify signs of pipe failure (leaks) along the slope. Recommend removing vegetation along pipe alignment to conduct proper inspection of structure and appurtenances. FIELD_STRUCT_DESC: 1 of 2: 8-inch steel irrigation pipe sleeved through 10-inch pipe through levee, 2.5 feet below the crown. Annular gap grouted. Concrete distribution box with slide gate located on the landside (LS) toe. Air vent located on the waterside (WS). (8-inch sleeved through 10-inch pipe authorized under Automatic Board Order (ABO) issued as Permit No. 11116, 1975 - C. E. & J. E. Upham; distribution box installed and pipe along LS slope removed and replaced with longer 10-inch steel pipe authorized under Permit No. 15372, 1993 - Department of Transportation [Caltrans]) [Additional Reference(s): DWR Levee Log, 1992. USACE Sacramento O&M Manual Unit No. 101, February 1962, (HLM 5.81). LMA encroachment station (STA) reference based on Map of Evacuation Route, Reclamation District 341 Sherman Island by Wagner Bonsignore Consulting Civil Engineers, A Corporation dated July 2012, STA 891+00] FS Date: 5/6/2009

8-inch pipe and 14-inch pipe on waterward side.

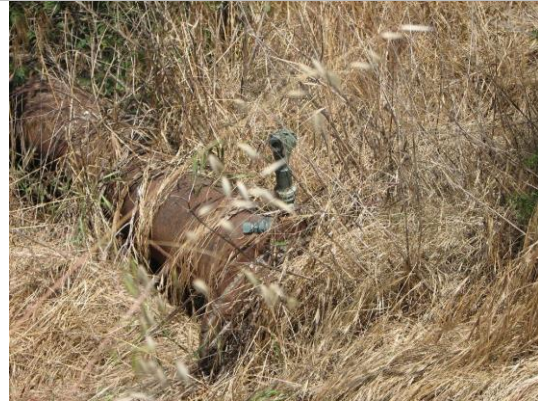
Photo 2 of 3 : UCIP_SP_2019_22258_37930.jpg

Comment Code						
Inspector Comment						
FS_ID:22258 DS_ID:24074 EP_NO: 11116 Repair Type: Non-Urgent Crossing Status: Found UCIP Comments: Dense vegetation limits the inspector's visibility to identify signs of pipe failure (leaks) along the slope. Recommend removing vegetation along pipe alignment to conduct proper inspection of structure and appurtenances. FIELD_STRUCT_DESC: 1 of 2: 8-inch steel irrigation pipe sleeved through 10-inch pipe through levee, 2.5 feet below the crown. Annular gap grouted. Concrete distribution box with slide gate located on the landside (LS) toe. Air vent located on the waterside (WS). (8-inch sleeved through 10-inch pipe authorized under Automatic Board Order (ABO) issued as Permit No. 11116, 1975 - C. E. & J. E. Upham; distribution box installed and pipe along LS slope removed and replaced with longer 10-inch steel pipe authorized under Permit No. 15372, 1993 - Department of Transportation [Caltrans]) [Additional Reference(s): DWR Levee Log, 1992. USACE Sacramento O&M Manual Unit No. 101, February 1962, (HLM 5.81). LMA encroachment station (STA) reference based on Map of Evacuation Route, Reclamation District 341 Sherman Island by Wagner Bonsignore Consulting Civil Engineers, A Corporation dated July 2012, STA 891+00] FS Date: 5/6/2009

Air vent located on waterward side.

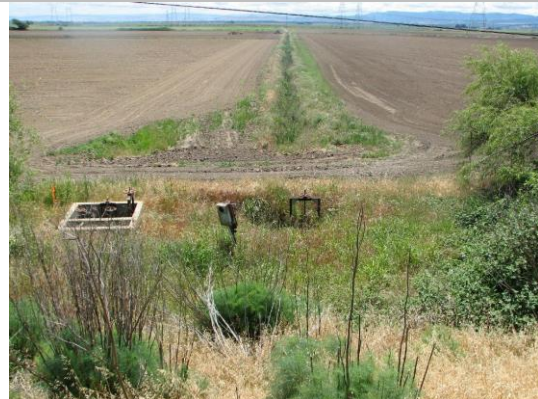
Photo 3 of 3 : UCIP_SP_2019_22258_37931.jpg

View of landward side.

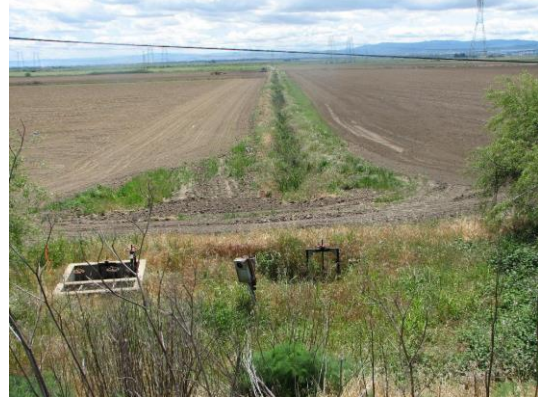
Photo 3 of 3 : UCIP_SP_2019_22259_37934.jpg

Comment Code						
Inspector Comment						
FS_ID:22259 DS_ID:24075 EP_NO: 1806 Repair Type: Non-Urgent Crossing Status: Found UCIP Comments: Dense vegetation limits the inspector's visibility to identify signs of pipe failure (leaks) along the slope. Recommend removing vegetation along pipe alignment to conduct proper inspection of structure and appurtenances. FIELD_STRUCT_DESC: 2 of 2: 14-inch steel irrigation pipe through the levee, 3 feet below the crown. Concrete distribution box with gate valve located on the landside (LS) toe. Air vent located on the waterside (WS). (14-inch pipe authorized under Permit No. 1806, 1959 - C. E. Upham, Jr.; distribution box installed and pipe along LS slope removed and replaced with longer 16-inch steel pipe authorized under Permit No. 15372, 1993 - Department of Transportation [Caltrans]) [Additional Reference(s): DWR Levee Log, 1992. USACE Sacramento O&M Manual Unit No. 101, February 1962, (HLM 5.81). LMA encroachment station (STA) reference based on Map of Evacuation Route, Reclamation District 341 Sherman Island by Wagner Bonsignore Consulting Civil Engineers, A Corporation dated July 2012, STA 891+00] FS Date: 5/6/2009

Gate located at the toe of the levee on landward side.

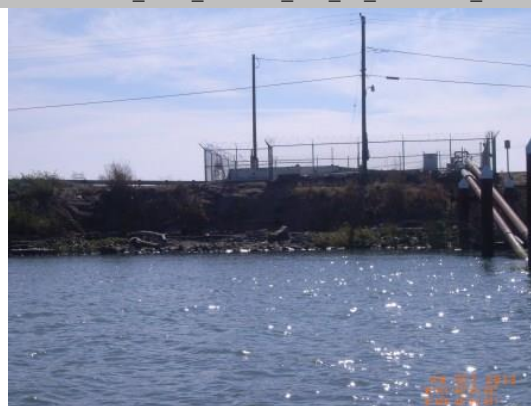
Photo 1 of 1 : SP_2019_RD0341_168_32_20190311_00001.jpg

LM Start	6.03	Rating **	U	Issue No.	32
LM End	6.16	Issue Type +	Ma	Location *	WS
Category	Supplemental			GPS Latitude/Longitude	
				Start	End
Item	2017 USACE Erosion Survey, DRAFT			38.080370 °	38.080526 °
				-121.728341 °	-121.730483 °
DWR ID	DWR_RD0341_02_f_2018_32				
Comment Code					
Inspector Comment					
2017 Site ID: SAC 7.3 L					
Status: Critical					
2017 Field Notes: No observed change..					
Site History: 2011 - Large slump at downstream end. Gully formed from surface runoff from the road. Shallow slumping throughout site.					
2012 - The gully at upstream end has increased in size and site continues to worsen.

USACE 2013 Photo #1

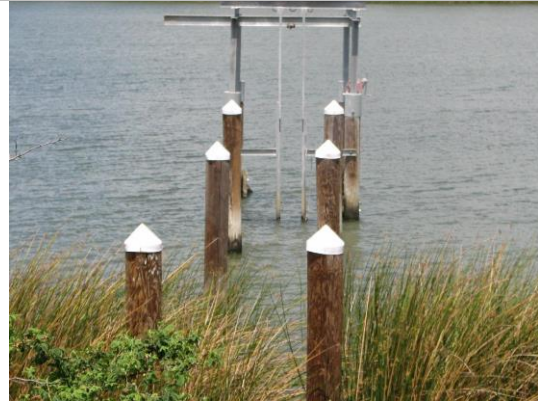
Photo 1 of 3 : UCIP_SP_2019_39861_71853.jpg

FS_ID:39861
DS_ID:24076
EP_NO: 11116
Repair Type: Non-Urgent
Crossing Status: Found
UCIP Comments: Need to contact owner to determine status of crossing. If crossing is no longer used will need to meet Title 23 requirements. Hole present in pipe section. Debris on waterward side--10-inch pipe section abandoned on slope. Dense vegetation limits the inspector's visibility to identify signs of pipe failure (leaks) along the slope. Recommend removing vegetation along pipe alignment to conduct proper inspection of structure and appurtenances.
FIELD_STRUCT_DESC: 12-inch steel irrigation pipe sleeved through 14-inch pipe through levee, 4.0 feet below crown. Annular gap grouted. Slide gate in distribution box on landside (LS). (12-inch sleeved through 14-inch pipe authorized under Automatic Board Order (ABO) issued as Permit No. 11116, 1975 - C. E. & J. E. Upham; widen and realign State HWY 160 and extend three irrigation pipes authorized under Permit No. 15372, 1993 - Department of Transportation [Caltrans]) [Additional Reference(s): DWR Levee Log, 1992. USACE Sacramento O&M Manual Unit No. 101, February 1962, (HLM 6.12). LMA encroachment station (STA) reference based on Map of Evacuation Route, Reclamation District 341 Sherman Island by Wagner Bonsignore Consulting Civil Engineers, A Corporation dated July 2012, STA 874+00]

View of structure located on waterward side.

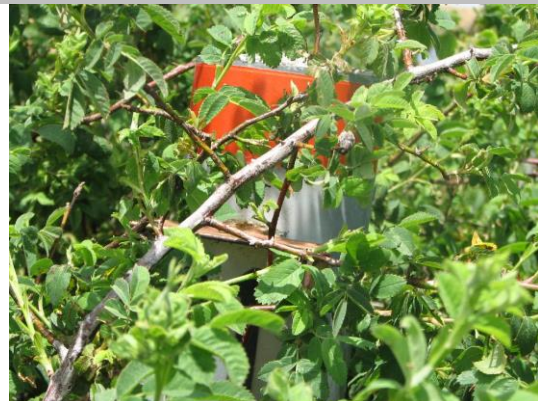
Photo 2 of 3 : UCIP_SP_2019_39861_71852.jpg

Marker visible on waterward side associated with crossing.

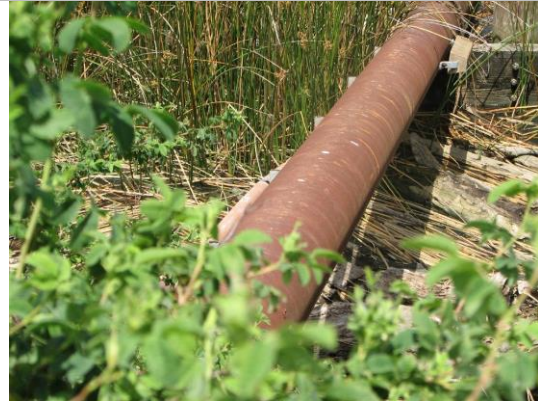
Photo 3 of 3 : UCIP_SP_2019_39861_71851.jpg

Comment Code						
Inspector Comment						
FS_ID:39861 DS_ID:24076 EP_NO: 11116 Repair Type: Non-Urgent Crossing Status: Found UCIP Comments: Need to contact owner to determine status of crossing. If crossing is no longer used will need to meet Title 23 requirements. Hole present in pipe section. Debris on waterward side-- 10-inch pipe section abandoned on slope. Dense vegetation limits the inspector's visibility to identify signs of pipe failure (leaks) along the slope. Recommend removing vegetation along pipe alignment to conduct proper inspection of structure and appurtenances. FIELD_STRUCT_DESC: 12-inch steel irrigation pipe sleeved through 14-inch pipe through levee, 4.0 feet below crown. Annular gap grouted. Slide gate in distribution box on landside (LS). (12-inch sleeved though 14-inch pipe authorized under Automatic Board Order (ABO) issued as Permit No. 11116, 1975 - C. E. & J. E. Upham; widen and realign State HWY 160 and extend three irrigation pipes authorized under Permit No. 15372, 1993 - Department of Transportation [Caltrans]) [Additional Reference(s): DWR Levee Log, 1992. USACE Sacramento O&M Manual Unit No. 101, February 1962, (HLM 6.12). LMA encroachment station (STA) reference based on Map of Evacuation Route, Reclamation District 341 Sherman Island by Wagner Bonsignore Consulting Civil Engineers, A Corporation dated July 2012, STA 874+00] FS Date: 5/6/2009

Pipe section visible on waterward side.

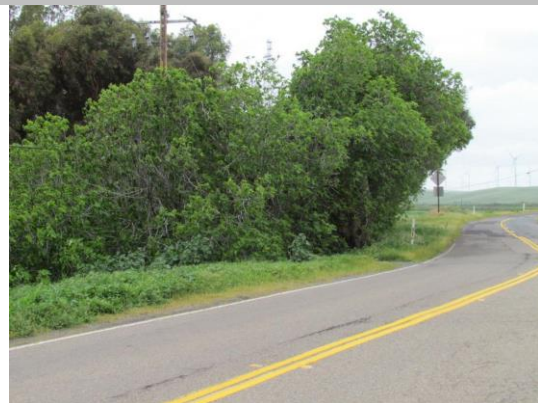
Photo 1 of 1 : SP_2019_RD0341_168_47_20190311_00014.jpg

LM Start	6.29	Rating **	U	Issue No.	47
LM End	6.32	Issue Type +	En	Location *	LS
Category	Earthen Levee			GPS Latitude/Longitude	
				Start	End
Item	Vegetation			38.081075 °	38.081142 °
				-121.732813 °	-121.733465 °
DWR ID	DWR_RD0341_02_f_2015_47				
Comment Code					
V6 : Landscaping					
Inspector Comment					
Remove the Fig trees or trim them up five foot from the ground so the levee slope can be inspected.

RD 341 landside levee slope mile 6.29-6.32.

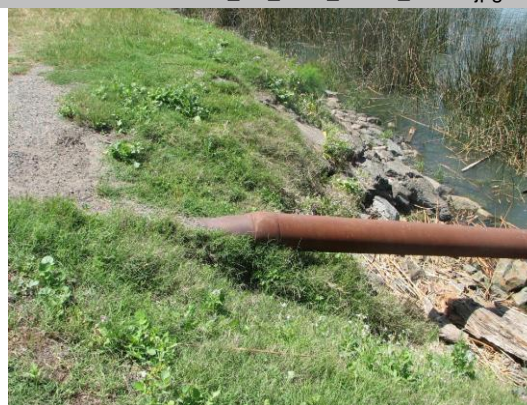
Photo 1 of 3 : UCIP_SP_2019_22261_37949.jpg

Comment Code					
Inspector Comment					
FS_ID:22261 DS_ID:24078 EP_NO: 11116 Repair Type: Non-Urgent Crossing Status: Found UCIP Comments: Dense vegetation limits the inspector's visibility to identify signs of pipe failure (leaks) along the slope. Recommend removing vegetation along pipe alignment to conduct proper inspection of structure and appurtenances. FIELD_STRUCT_DESC: 12-inch steel pipe of unknown purpose through the levee, 2 feet below the crown. Siphon breaker on landside (LS) slope. Rock revetment on waterside (WS) slope. (12-inch authorized under Automatic Board Order (ABO) issued as Permit No. 11116, 1975 - C. E. & J. E. Upham) [Additional Reference(s): DWR Levee Log, 1992. USACE Sacramento O&M Manual Unit No. 101, February 1962, (HLM 6.30). LMA encroachment station (STA) reference based on Map of Evacuation Route, Reclamation District 341 Sherman Island by Wagner Bonsignore Consulting Civil Engineers, A Corporation dated July 2012, STA 857+00] FS Date: 5/6/2009

Side view of pipe on waterward side.

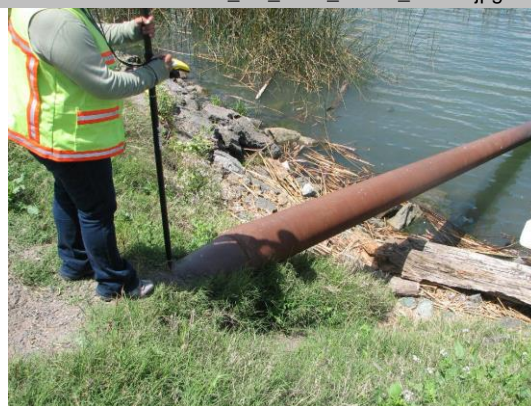
Photo 2 of 3 : UCIP_SP_2019_22261_37947.jpg

Comment Code						
Inspector Comment						
FS_ID:22261 DS_ID:24078 EP_NO: 11116 Repair Type: Non-Urgent Crossing Status: Found UCIP Comments: Dense vegetation limits the inspector's visibility to identify signs of pipe failure (leaks) along the slope. Recommend removing vegetation along pipe alignment to conduct proper inspection of structure and appurtenances. FIELD_STRUCT_DESC: 12-inch steel pipe of unknown purpose through the levee, 2 feet below the crown. Siphon breaker on landside (LS) slope. Rock revetment on waterside (WS) slope. (12-inch authorized under Automatic Board Order (ABO) issued as Permit No. 11116, 1975 - C. E. & J. E. Upham) [Additional Reference(s): DWR Levee Log, 1992. USACE Sacramento O&M Manual Unit No. 101, February 1962, (HLM 6.30). LMA encroachment station (STA) reference based on Map of Evacuation Route, Reclamation District 341 Sherman Island by Wagner Bonsignore Consulting Civil Engineers, A Corporation dated July 2012, STA 857+00] FS Date: 5/6/2009

View of pipe and rip rap on waterward side.

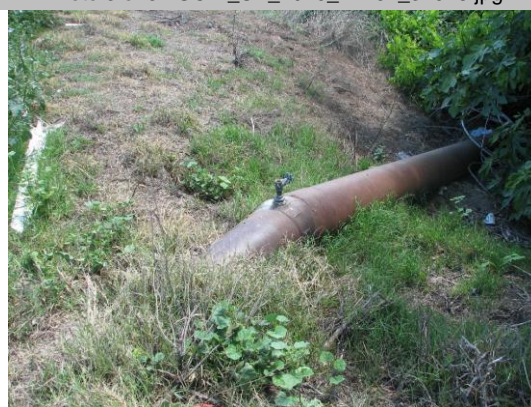
Photo 3 of 3 : UCIP_SP_2019_22261_37948.jpg

View of crossing on landward slope.

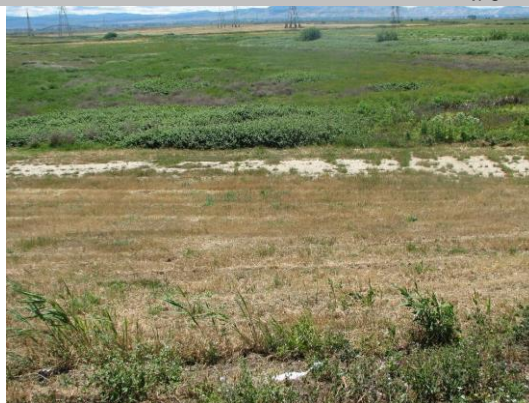
Photo 1 of 2 : UCIP_SP_2019_22262_37953.jpg

Comment Code						
Inspector Comment						
FS_ID:22262 DS_ID:24079 EP_NO: 11107 Repair Type: Non-Urgent Crossing Status: Indicator Found UCIP Comments: Need to contact owner to determine status of crossing. If crossing is no longer in used owner will need to comply with Title 23. Dense vegetation limits the inspector's visibility to identify signs of pipe failure (leaks) along the slope. Recommend removing vegetation along pipe alignment to conduct proper inspection of structure and appurtenances. FIELD_STRUCT_DESC: 4-inch steel pipe type unknown through the levee, 4 feet below the crown. (4-inch pipe authorized under Permit No. 11107, 1975 - G. Celli) [Additional Reference(s): DWR Levee Log, 1992. LMA encroachment station (STA) reference based on Map of Evacuation Route, Reclamation District 341 Sherman Island by Wagner Bonsignore Consulting Civil Engineers, A Corporation dated July 2012, STA 851+00] FS Date: 5/6/2009

View of landward side no evidence of crossing.

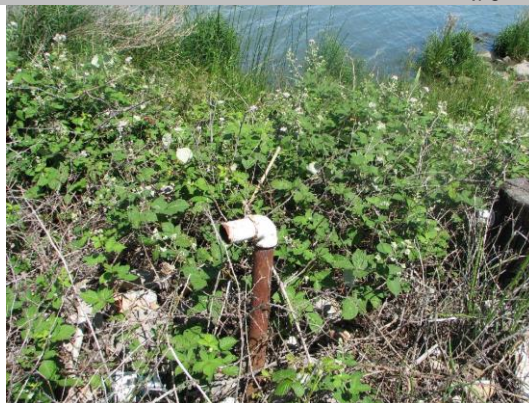
Photo 2 of 2 : UCIP_SP_2019_22262_37952.jpg

Comment Code						
Inspector Comment						
FS_ID:22262 DS_ID:24079 EP_NO: 11107 Repair Type: Non-Urgent Crossing Status: Indicator Found UCIP Comments: Need to contact owner to determine status of crossing. If crossing is no longer in used owner will need to comply with Title 23. Dense vegetation limits the inspector's visibility to identify signs of pipe failure (leaks) along the slope. Recommend removing vegetation along pipe alignment to conduct proper inspection of structure and appurtenances. FIELD_STRUCT_DESC: 4-inch steel pipe type unknown through the levee, 4 feet below the crown. (4-inch pipe authorized under Permit No. 11107, 1975 - G. Celli) [Additional Reference(s): DWR Levee Log, 1992. LMA encroachment station (STA) reference based on Map of Evacuation Route, Reclamation District 341 Sherman Island by Wagner Bonsignore Consulting Civil Engineers, A Corporation dated July 2012, STA 851+00] FS Date: 5/6/2009

View of waterward side air vent pipe could be associated with crossing.

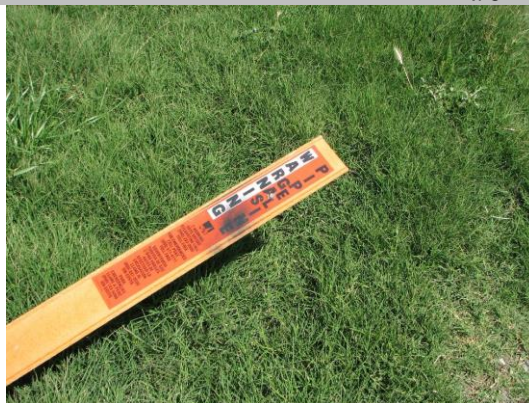
Photo 3 of 3 : UCIP_SP_2019_22263_37960.jpg

Comment Code						
Inspector Comment						
FS_ID:22263 DS_ID:24081 EP_NO: 892 Repair Type: Non-Urgent Crossing Status: Found UCIP Comments: Need to contact owner to determine status of crossing. Need date of last inspection and confirmation that crossing is still in operable condition. FIELD_STRUCT_DESC: 1 of 2: 12.75-inch steel gas line through the levee, 2.0 feet below the crown. Concrete cutoff wall around pipes at center of levee. Location marker on waterside (WS) slope. Concrete control box and valve pit on landside (LS) slope. Utility marker contact information includes Contact prior to Excavation call 1-800-227-2600 or Emergency Contact 1-800-811-4111. (12.75-inch gas line authorized under Permit No. 892, 1942 - Pacific Gas and Electric Company [PG&E]) [Additional Reference(s): DWR Levee Log, 1992. LMA encroachment station (STA) reference based on Map of Evacuation Route, Reclamation District 341 Sherman Island by Wagner Bonsignore Consulting Civil Engineers, A Corporation dated July 2012, STA 826+00] FS Date: 5/6/2009

Marker damaged on waterward side.

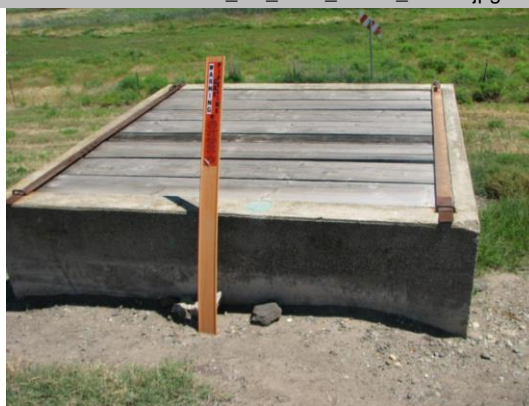
Photo 1 of 3 : UCIP_SP_2019_22264_37965.jpg

Comment Code					
Inspector Comment					
FS_ID:22264 DS_ID:24234 EP_NO: 892 Repair Type: Non-Urgent Crossing Status: Found UCIP Comments: Need to contact owner to determine status of crossing. Need date of last inspection and confirmation that crossing is still in operable condition. FIELD_STRUCT_DESC: 2 of 2: 12.75-inch steel gas line through the levee, 2.0 feet below the crown. Concrete cutoff wall around pipes at center of levee. Location marker on waterside (WS) slope. Concrete control box and valve pit on landside (LS) slope. Utility marker contact information includes Contact prior to Excavation call 1-800-227-2600 or Emergency Contact 1-800-811-4111. (12.75-inch gas line authorized under Permit No. 892, 1942 - Pacific Gas and Electric Company [PG&E]) [Additional Reference(s): DWR Levee Log, 1992. LMA encroachment station (STA) reference based on Map of Evacuation Route, Reclamation District 341 Sherman Island by Wagner Bonsignore Consulting Civil Engineers, A Corporation dated July 2012, STA 826+00] FS Date: 5/6/2009

Concrete box and marker located on near landward shoulder. Additional marker located at the levee toe.

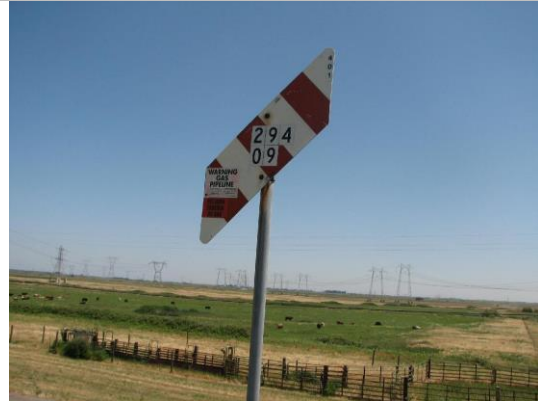
Photo 1 of 2 : UCIP_SP_2019_22267_37978.jpg

FS_ID:22267
DS_ID:24193
EP_NO: 15777
Repair Type: Non-Urgent
Crossing Status: Indicator Found
UCIP Comments: Need to contact owner to determine status of crossing. Need date of last inspection and confirmation that crossing is still in operable condition. Multiple crossings in general area need to clarify which pipes are in this levee section.
FIELD_STRUCT_DESC: 42-inch steel natural gas line through the levee, bored 30-feet below the channel and both levees. Utility marker contact information includes Contact prior to Excavation call 1-800-227-2600 or Emergency Contact 1-800-811-4111. (42-inch line authorized under authorized Permit No. 15777, 1993 - PGT - PG&E Pipeline Expansion Project) [Additional Reference(s): LMA encroachment station (STA) reference based on Map of Evacuation Route, Reclamation District 341 Sherman Island by Wagner Bonsignore Consulting Civil Engineers, A Corporation dated July 2012, STA 826+00]

Marker located on landward side.

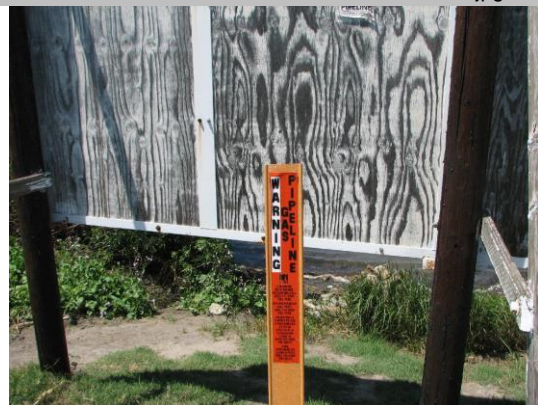
Photo 2 of 2 : UCIP_SP_2019_22267_37977.jpg

Marker located on waterward side.

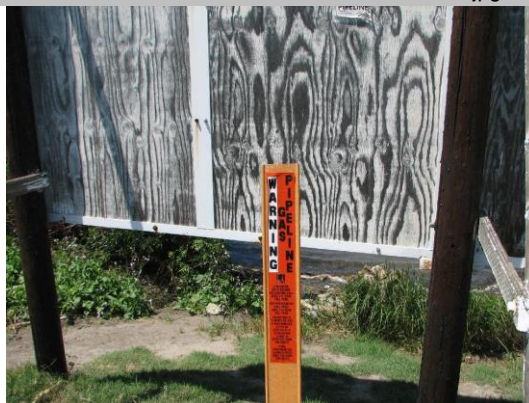
Photo 2 of 2 : UCIP_SP_2019_22268_37979.jpg

Utility marker located on waterward side.
